Microscopic and metallurgical aspects of the Space Shuttle Columbia accident investigation and reconstruction

Steve McDanels¹

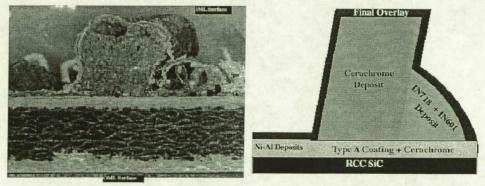
Therefore, X-ray dot mapping was conducted, which provided more understandable data, both in terms of slag layering and composition. An X-ray dot map is generated by performing numerous EDX scans for individual elements, then compiling the scans in a visual representation. Eventually, specimens consisting of not only the slag, but of the adjacent RCC substrate as well were cross-sectioned. X-Ray dot mapping of the materialographically-mounted and -polished cross- sections provided a visual representation of both the layering sequence and compositional characteristics of the slag, Figure 1.

Figure 1. X-Ray Dot Map of a slag deposit harvested from LH RCC Panel 8. The top left pane represents the cross-section; each sequential pane represents the relative amount present of a specific element, respectively C, O, Al, Si, Ti, Cr, Fe, and Ni. The vertical legend to the right of the dot map indicates the relative intensity of counts for each element; black indicates fewer counts, white denotes a higher number of counts. [1]
